Ndunda

**INACCT**  
Resilience

*Designing Inclusive African  
Coastal City Resilience*

# Integrated climate change risk, resilience & disaster response profile – urban informal settlement

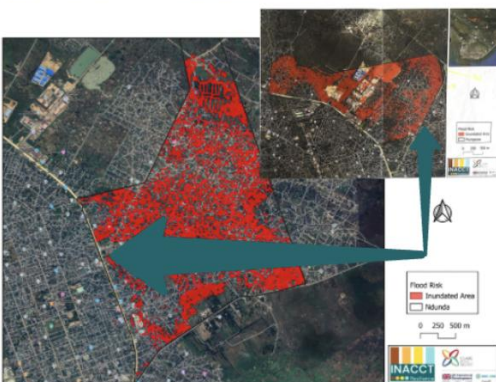
### 2. Ndunda/Mungassa unpaved main artery 'Six', regularly flooded

- The informal neighbourhood's main access roads (large dirt tracks linking the area to the highway) are increasingly congested, degraded and flood-prone. In Mbamba, the only main access route into this part of Mungassa, known as "Six", is frequently underwater and often impassable for vehicles, preventing its use for evacuation and limiting access for rescue teams during floods.

- Despite this, "Six" carries thousands of motorists, motorcyclists and pedestrians daily. This constant pressure has left the road deeply rutted, muddy and slow to navigate, with water lingering for months after the rainy season.

- In response to residents' requests, authorities have acknowledged the need for roadside drainage to divert water away from the road. However, as the road also functions as a commercial hub, informal stalls and small structures remain along its edges, with eviction efforts proving unsustainable over time. Residents say this further increases risks for both drivers and pedestrians.

- When flooded or covered with mud and standing water this road (essential for accessing inland areas of Mungassa and Ndunda) becomes difficult or unusable. Residents may have to walk over an hour to reach the nearest paved road and access transport to work, school or markets, placing a strain on daily life. During storms and cyclones, it becomes impassable, blocking evacuation and emergency access for large parts of both neighbourhoods and creating a critical bottleneck.

| Priority area | Specific action / research area | Lead actor | Potential partner/s | Time line | Status |
|---|---|---|---|---|---|
| Infra-structure resilience | <p>Paving and drainage of Road Six (main artery linking Mungassa and Ndunda to N6 highway), including roadside ditches</p> <p>Replacement of informal Ndunda North crossing with permanent structure over stormwater drainage canal.</p> | CMB | World Bank/AFD<br>NUCA; AIAS | | In progress |
